**GRI White Paper #5**

**In-Situ Separation of GCL Panels Beneath Exposed Geomembranes**

**Robert M. Koerner and George R. Koerner  
Geosynthetic Institute  
475 Kedron Avenue  
Folsom, PA 19033 USA**

**April 15, 2005**

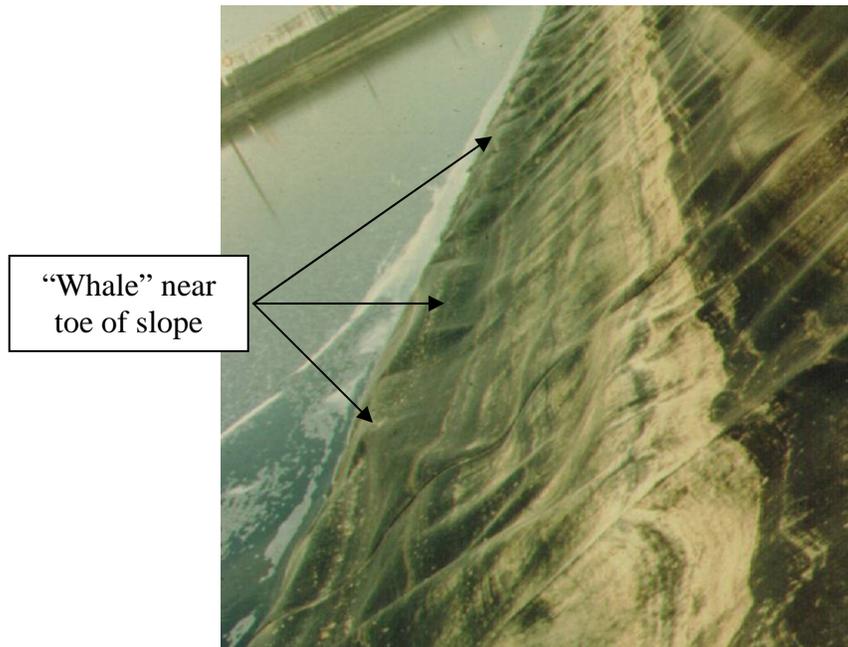
2. *Longitudinal Steep Slope Tensioning of the GCL* - Along with the daily expansion and contraction of the exposed geomembrane comes a gradually downslope moving wave which accumulates at the toe of the slope. This was observed at three of the cases in Table 1 and is regularly observed in exposed reservoir liners, see Figure 5.

Figure 5 - Horizontally oriented geomembrane wave in an exposed reservoir liner near the toe of slope. [This site did not have an underlying GCL and is only shown to illustrate the type of wave that exists in exposed geomembranes].
