**GSI White Paper #25**

**The Separation-In-Plane (SIP) Mode of Failure When Testing  
Polyolefin Geomembrane Seams**

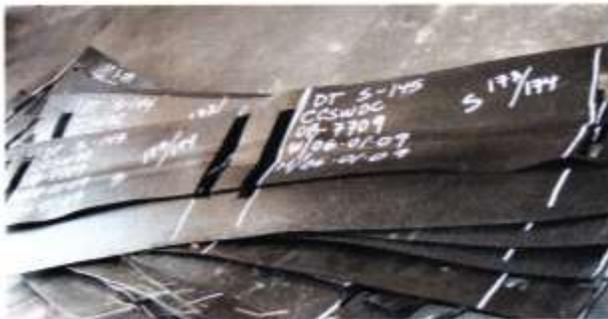
(a) Test samples with destructive test specimens removed

Figure 1 – Geomembrane field seam samples and repair.

The destructive testing of field seamed geomembrane edges\* and ends has been an ongoing quality control and quality assurance practice for over thirty-years. The usual procedure is to sample, i.e., physically cut out, sections of the actual production seam from which smaller test specimens are die-cut in the laboratory for testing until failure occurs; see Figure 1a for a number of these samples with test specimens removed. Obviously, this cutting out of the field samples must be suitably repaired with patches as shown in Figure 1b.

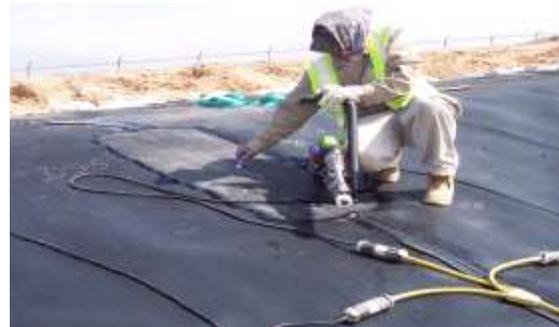
(b) Repair patch placed over previously cutout destructive seam location
