**GRI White Paper #5**

**In-Situ Separation of GCL Panels Beneath Exposed Geomembranes**

**Robert M. Koerner and George R. Koerner  
Geosynthetic Institute  
475 Kedron Avenue  
Folsom, PA 19033 USA**

**April 15, 2005**

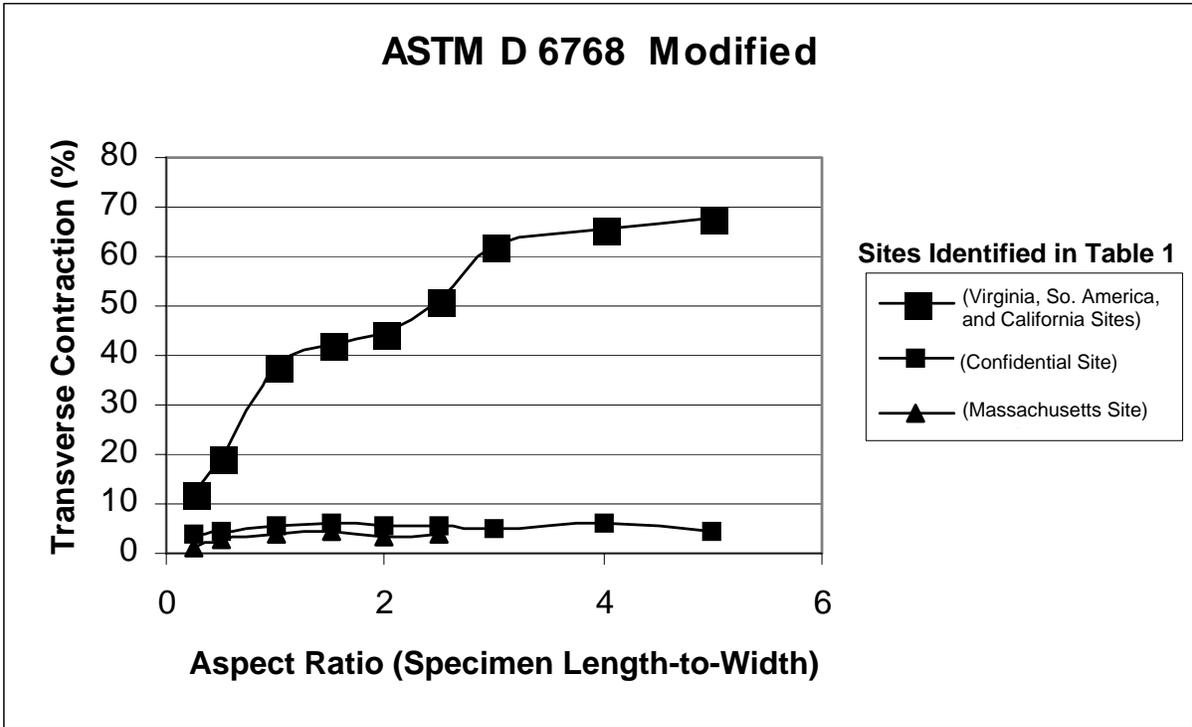
Figure 7 - Results of tensile tests with measurement of transverse contraction, aka “necking”, versus Aspect Ratio of original specimen length-to-width measurement.

This important set of curves readily provides the necessary information and explanation into why the panel separation distances described in Table 1 are so large; particularly the California site which experienced, by far, the greatest panel separation distances. Table 2 gives the requisite calculations based upon a GCL panel width of 4.4 m (14.5 ft). While the data speaks for itself, one can easily substantiate the magnitude of GCL panel separation distances in all of the cases (including the California site) under investigation.
